| Schematics Page Index (Title / Revision / Change Date) | | | | |

# Huron River Platform+ ATI Whistler/Seymour Discrete Graphic

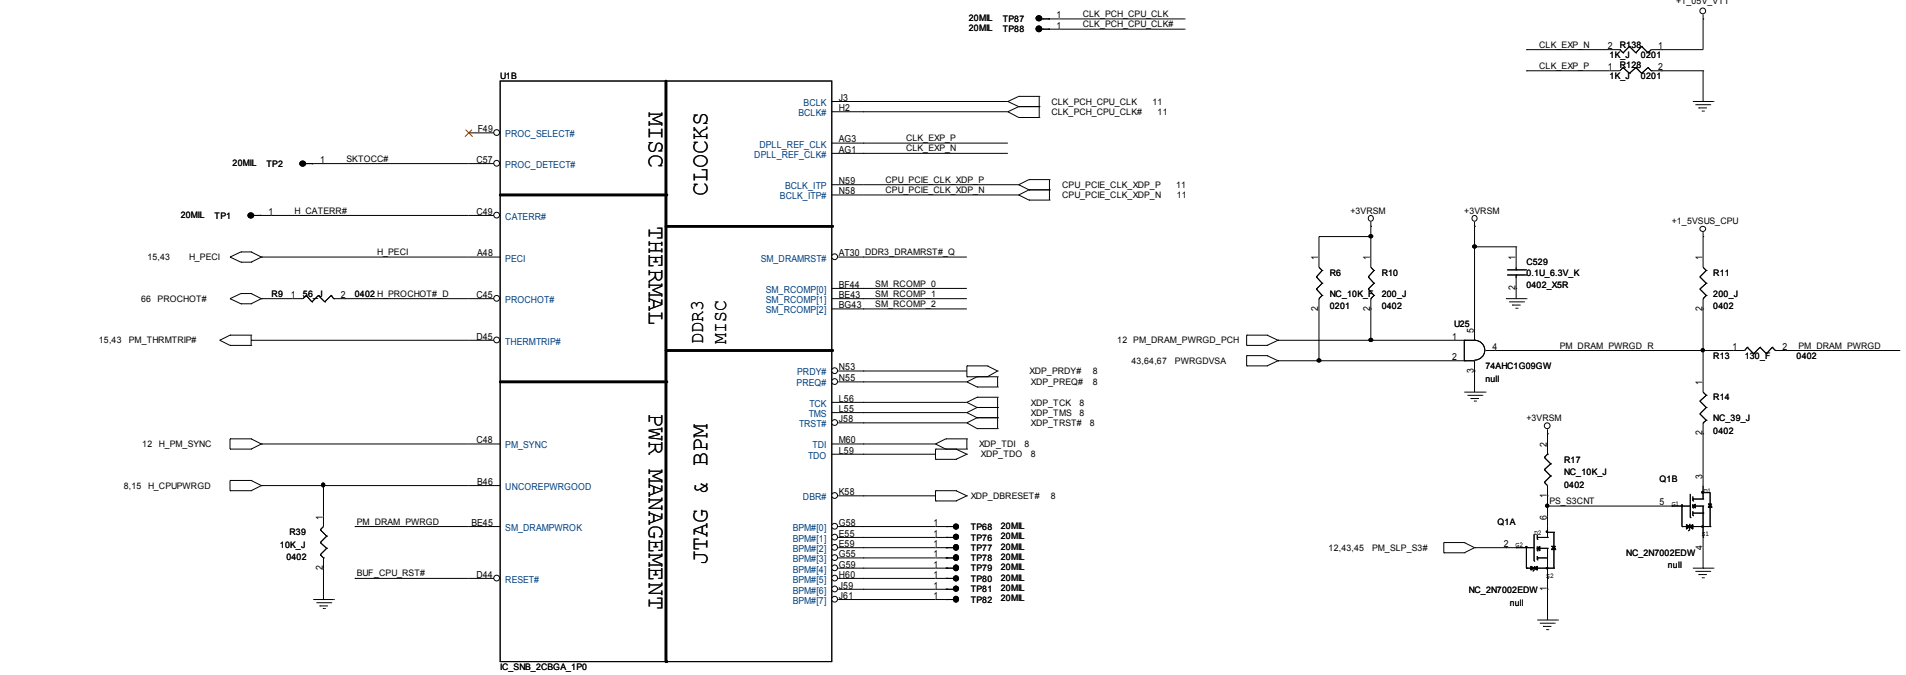
Buffered reset to CPU

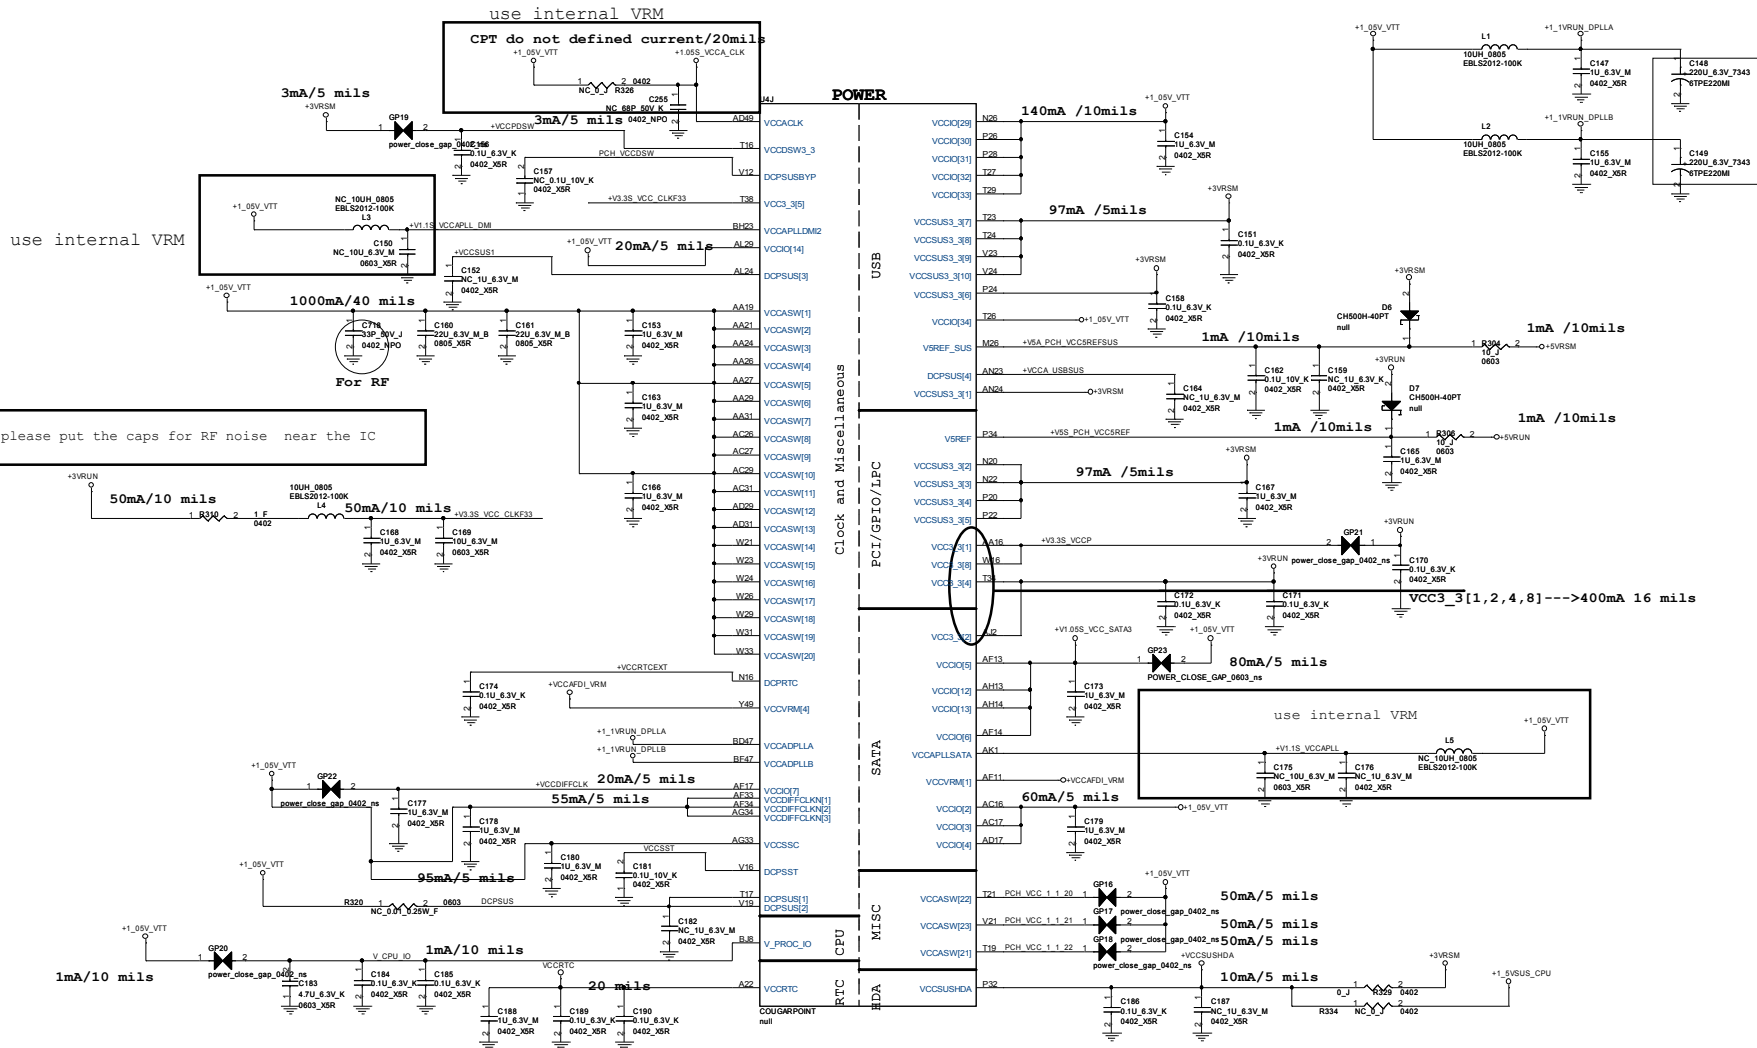
2010.1227  
For quality issue 1C-33T0227-M102  
forbit to use C148,C149 change to  
1C-41T0227-M100

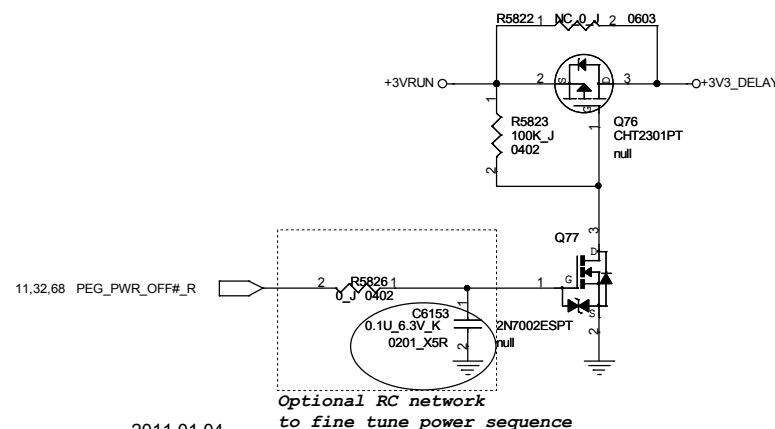
2011.01.04

For +3VRUN voltage drop issue NPIT suggest C6153  
change to mount

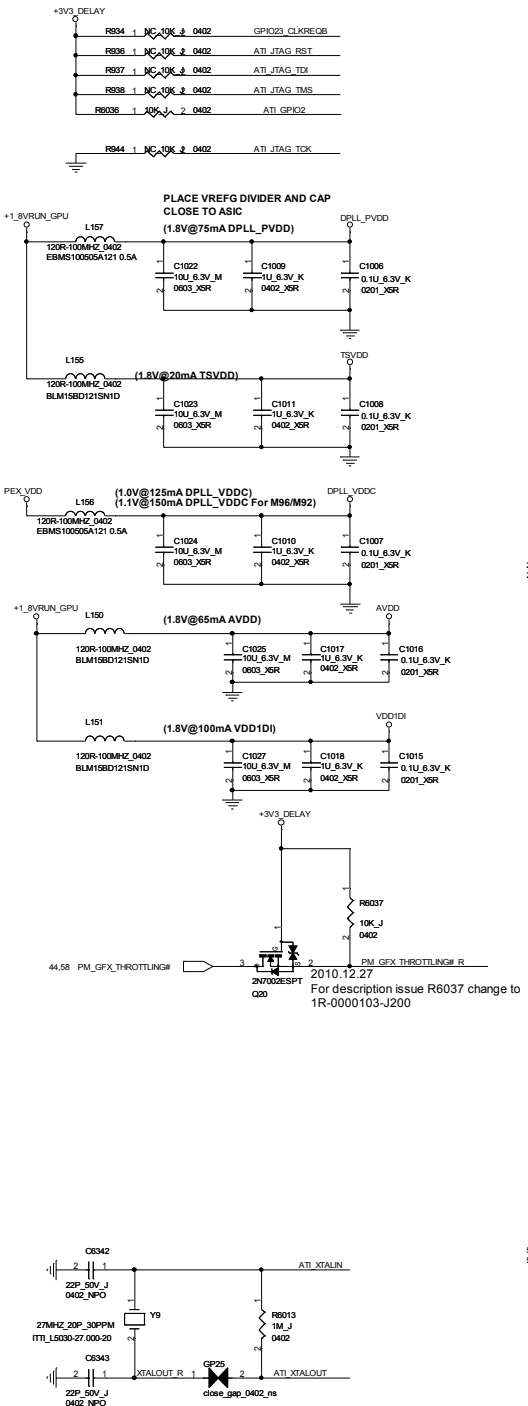
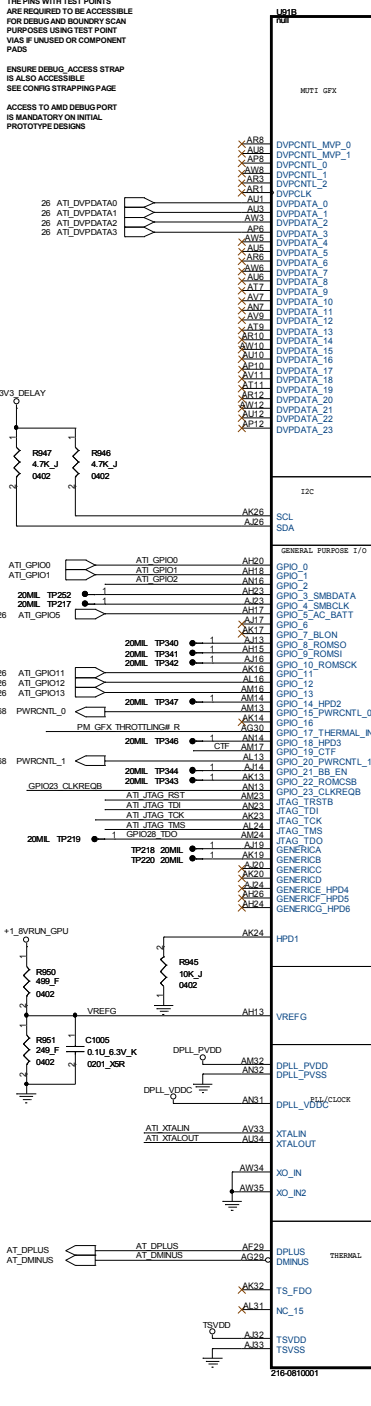
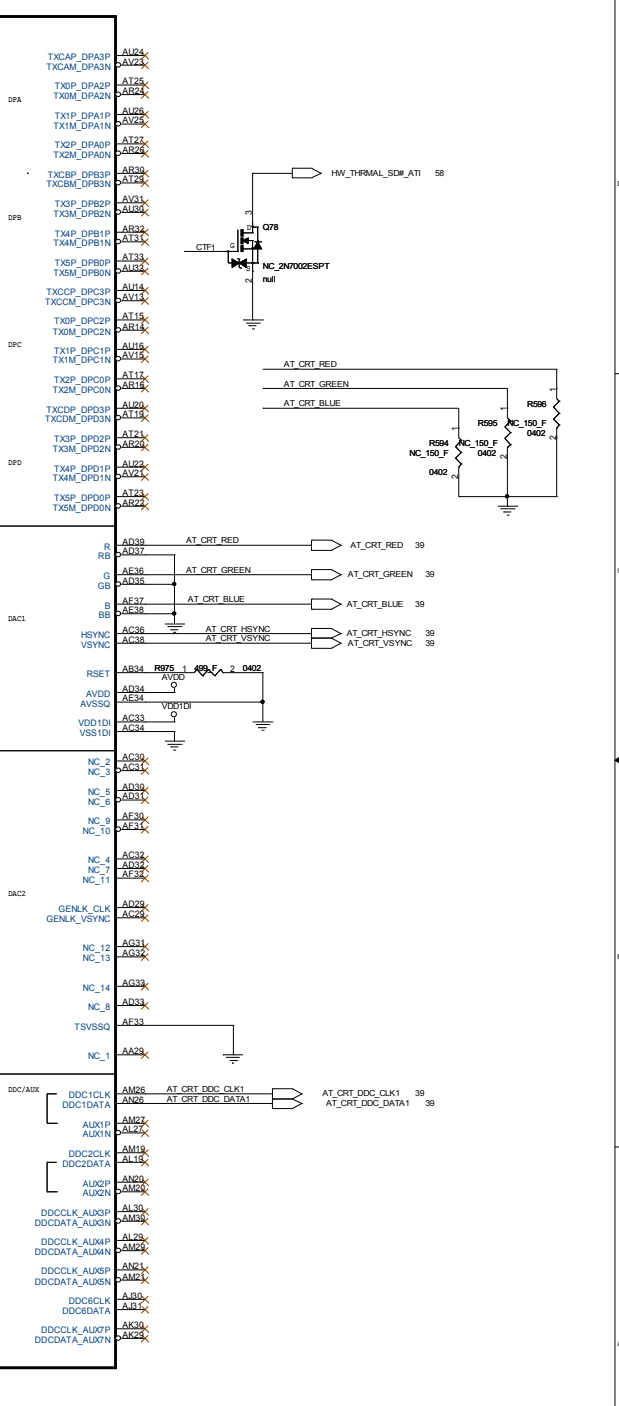
5.3.1 Switchable Graphics - 27-MHz Clock for DGPU  
DGPU's requiring a 27MHz clock in a Switchable Graphics configuration shall have to use a discrete crystal and should not source this clock from the PCH. This restriction does not apply to Discrete-graphics only systems. Refer to the WW10 Huron River Platform Message of the week for more details.

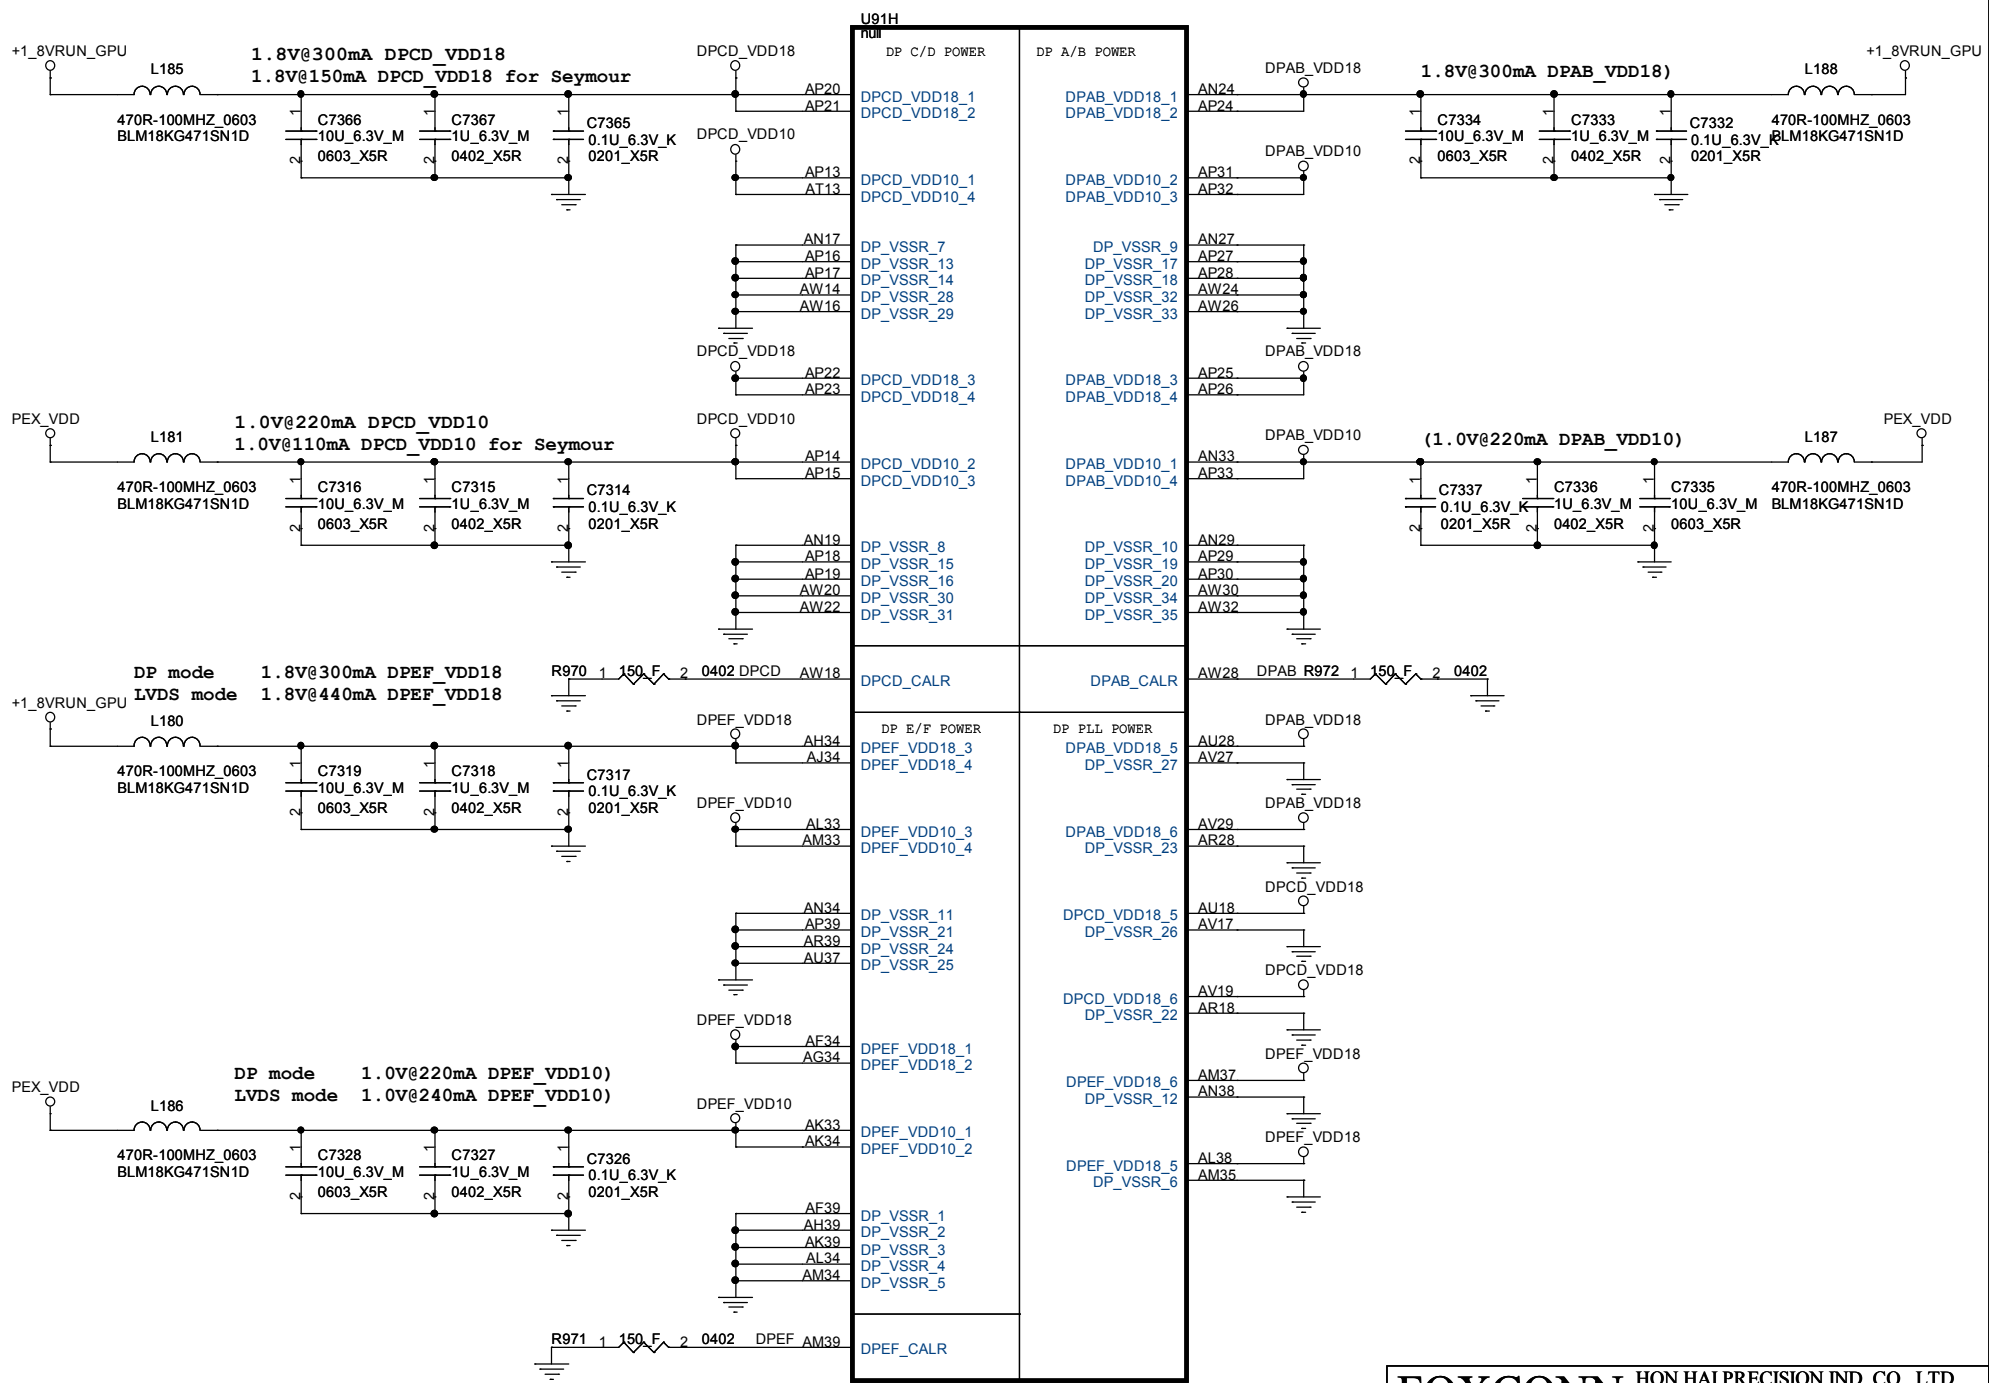
R970/R971/R972 close to U91  
change R970/R971/R972 precision from 5% to 1%  
for follow check list 2010/06/04

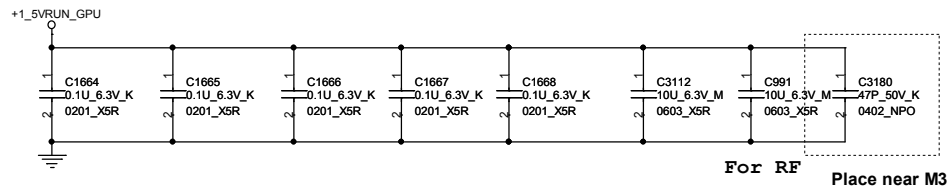
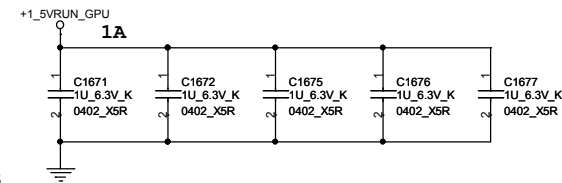
### Place around the VRAM M3

change C3110,C3111,C3112,C3113,C877,C990,C991 and C992 to 10u 0702

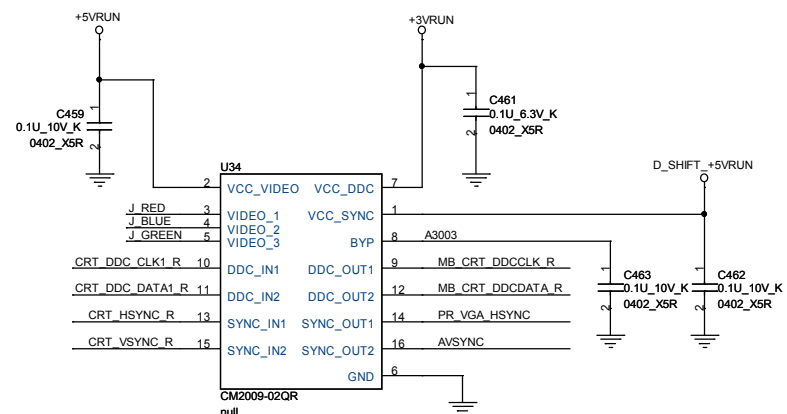
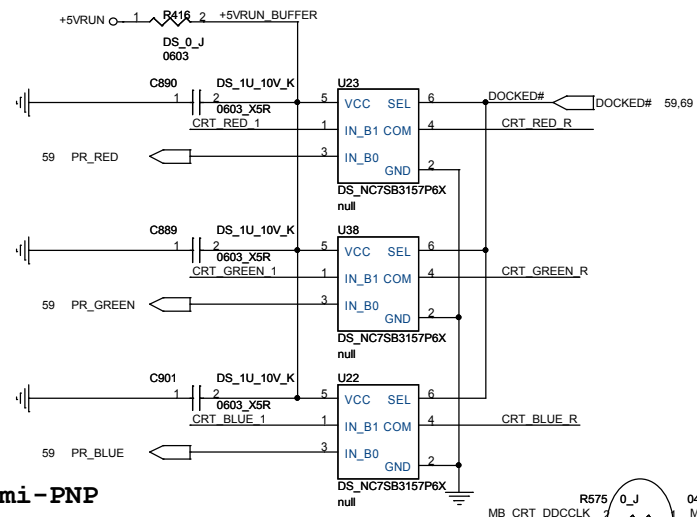
## CRT CONNECTOR

For EMI

10/27  
[69 -- Others power plane] Change PR5 to 470K pwr request -- ECR  
[39 -- CRT] Change R574/R576 to 4.75K for E010 CRT fail issue -- ECR  
[61-- Identify IC] Change PU22 to R5G05000N753NF pwr request -- ECR

11/26  
[39 -- CRT] Dummy C639/C638/C467/C470 (DDC rise time fail issue)  
[39 -- CRT] Change R471/R472 to 3.3K (SI DDC fail issue)  
[43 -- EC + SPI ROM] RSM\_ON\_EC add 100k pull low (SI PWRBTN# pulse issue)  
[45 -- Debug Port] Change CN7 Pin17 to PWRSW#\_DB (MOR QA request)  
[15 -- PCH (GPIO,VSS\_NCTF,RSVD)] Update MEM PRS table

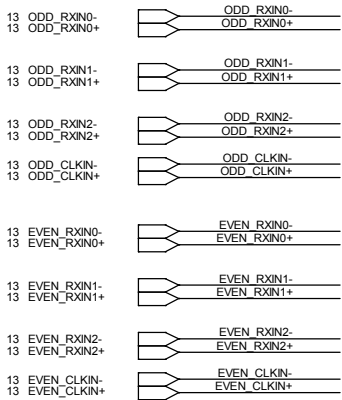
LVDS CONNECTOR

MOR request change to 1A, and need add power pins 10/15

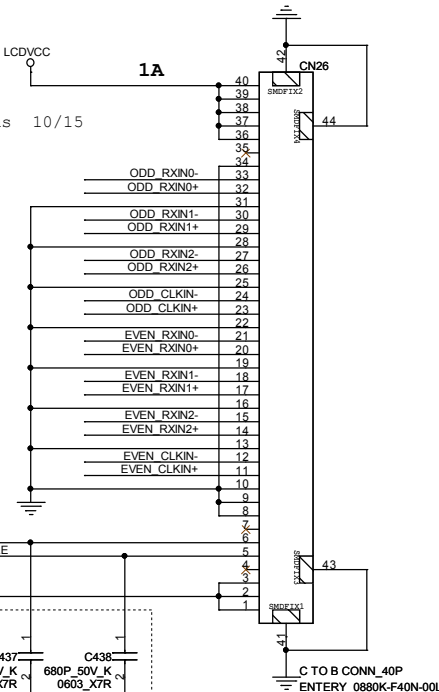
For rush current issue

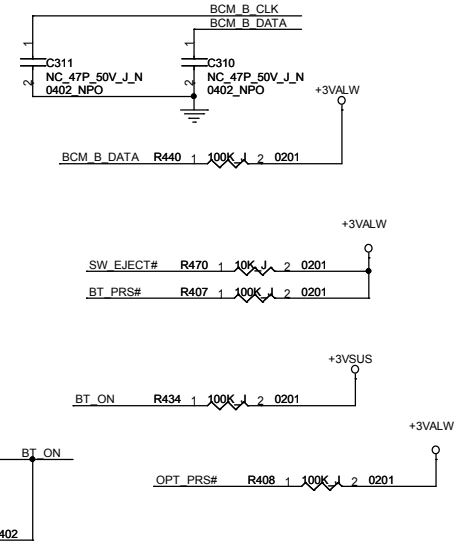
2010.12.24  
For BT2\_PRIS# Issue R436,R407 change from NC to munt,R441 change from munt to NC

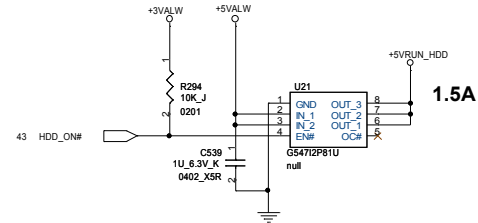
## HDD Power

Change Power circuit for short test fail issue 10/14

11/29  
[69 -- Others power plane] Change PU3 power supply to +5VALW (Power request)  
[69 -- Others power plane] Change PR44 TO 200K (Power request)  
[47 -- SATA HDD] Add C232 (SSD power pk-pk ripple test fail)  
[59 -- MB to DB Conn.] Add R52 (reserve for over load test fail)  
[59 -- MB to DB Conn.] Change CN9 PIN 39 to +3VALW from AC\_OFF\_EC#(Power request)  
[39 -- CRT] Add C639/C638 back  
[39 -- CRT] Change R472/R471 back to 3.9K  
[14 -- PCH (PCI,USB,NVRAM)] Add C826 (EMC request)  
[48 -- SATA ODD] Mount D13 and change to SL22 (EMC request)  
[43 -- EC + SPI ROM] R904 change to 10K follow T8 circuit solution (NPIT)  
[40 -- LVDS] Change CN26 Pin 36/37/40 to LCDVCC from NC (Reserve for 15'' )  
[40 -- LVDS] Change CN26 Pin 34 to GND (EMI request)  
[43 -- EC + SPI ROM] Reserve R145 for PECI undershoot issue

12/02  
[59 -- MB to DB Conn.] Delete R52 (Move to DOCKING DB)  
[59 -- MB to DB Conn.] Add R1101/R1102/R1103/R1104/R1105/R1106 (For over load test fail issue ,shall change to fuse)  
[47 -- SATA HDD] Add R1107 (For over load test fail issue ,shall change to fuse)  
[53 -- Mini-PCIE Card (WLAN)] Add R1108 (For over load test fail issue ,shall change to fuse)  
12/03  
[27 -- ATI VGA (I/O) 3/8] Add Q20/R6037 (+3V3\_DELAY leakage issue)  
[11 -- PCH (PCI-E,SMBUS,CLK)] Reserve R146 follow NPIT suggestion  
[47 -- SATA HDD] Delete R1107 (Placement difficulty)  
[59 -- MB to DB Conn.] R1101 co-lay with F2,R1102 co-lay with F3,R1103 co-lay with F10,R1104 co-lay with F11  
[59 -- MB to DB Conn.] R1105 co-lay with F14,R1106 co-lay with F15  
[53 -- Mini-PCIE Card (WLAN)] R1108 co-lay with F13  
MP  
12/24  
[10 -- PCH] For PVT hung up 767C issue change C121 from 2.2uF to 10uF  
[43 -- EC+SPI ROM] For ALS follow MOR request R6032 changefrom 120Kohm to 110Kohm

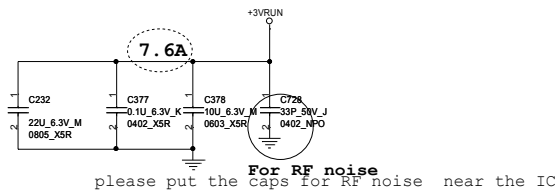
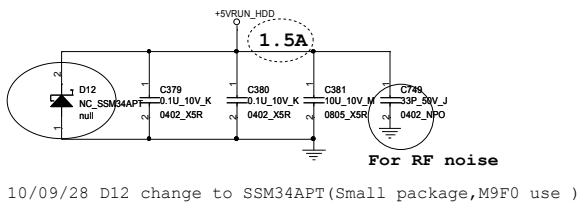
## SATA HDD CONN

10/09/28 D12 change to SSM34APT (Small package, M9F0 use)

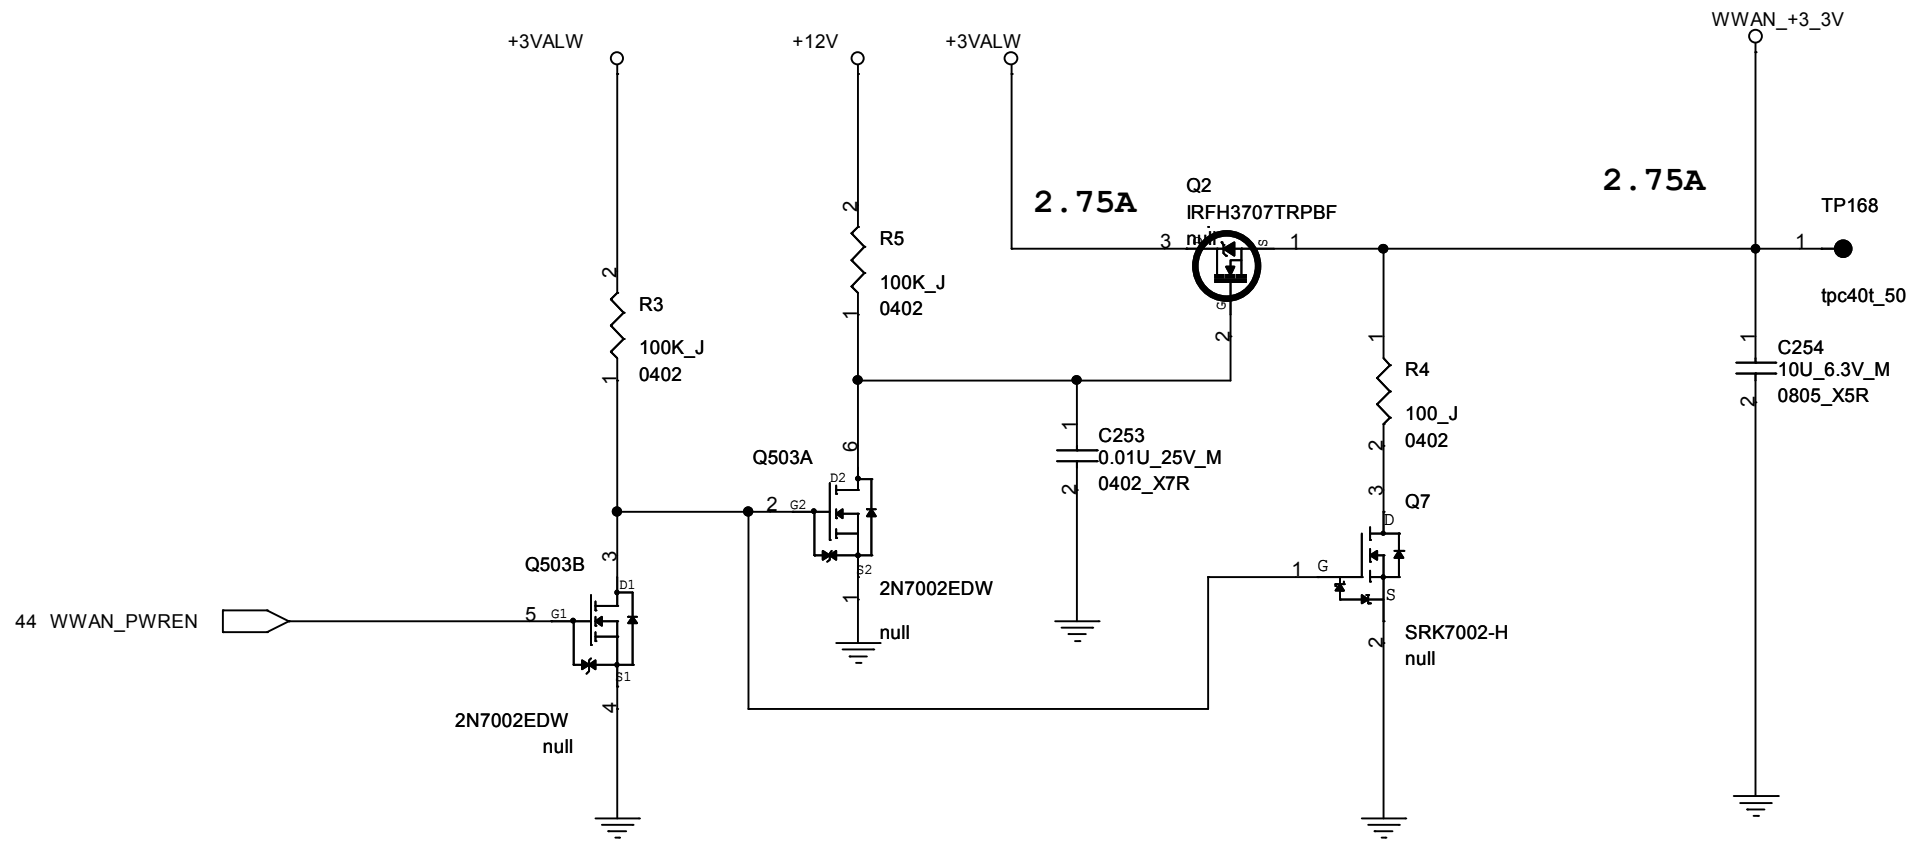
| Title <b>Mini-PCIE Card (WWAN)</b> | | | |

2010.1224  
Due to concern of fuse voltage drop is larger than resistor, need delete F13 and add R1108

For RF noise please put it near the connector

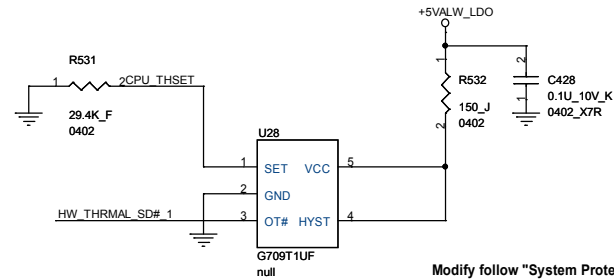
# HW THERMAL PROTECTION

HW thermal shut down temperature setting  
80 celcius degree. Put Near CPU .

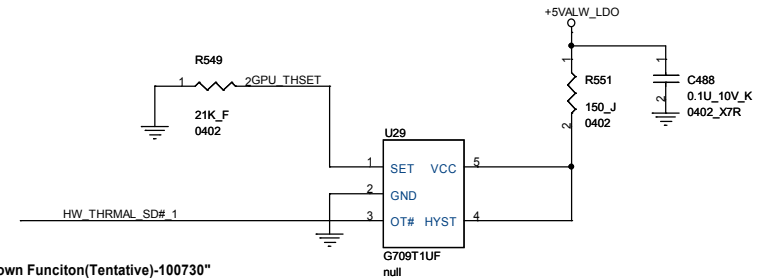
# HW THERMAL PROTECTION

HW thermal shut down temperature setting  
91.5 celcius degree. Put Near GPU .

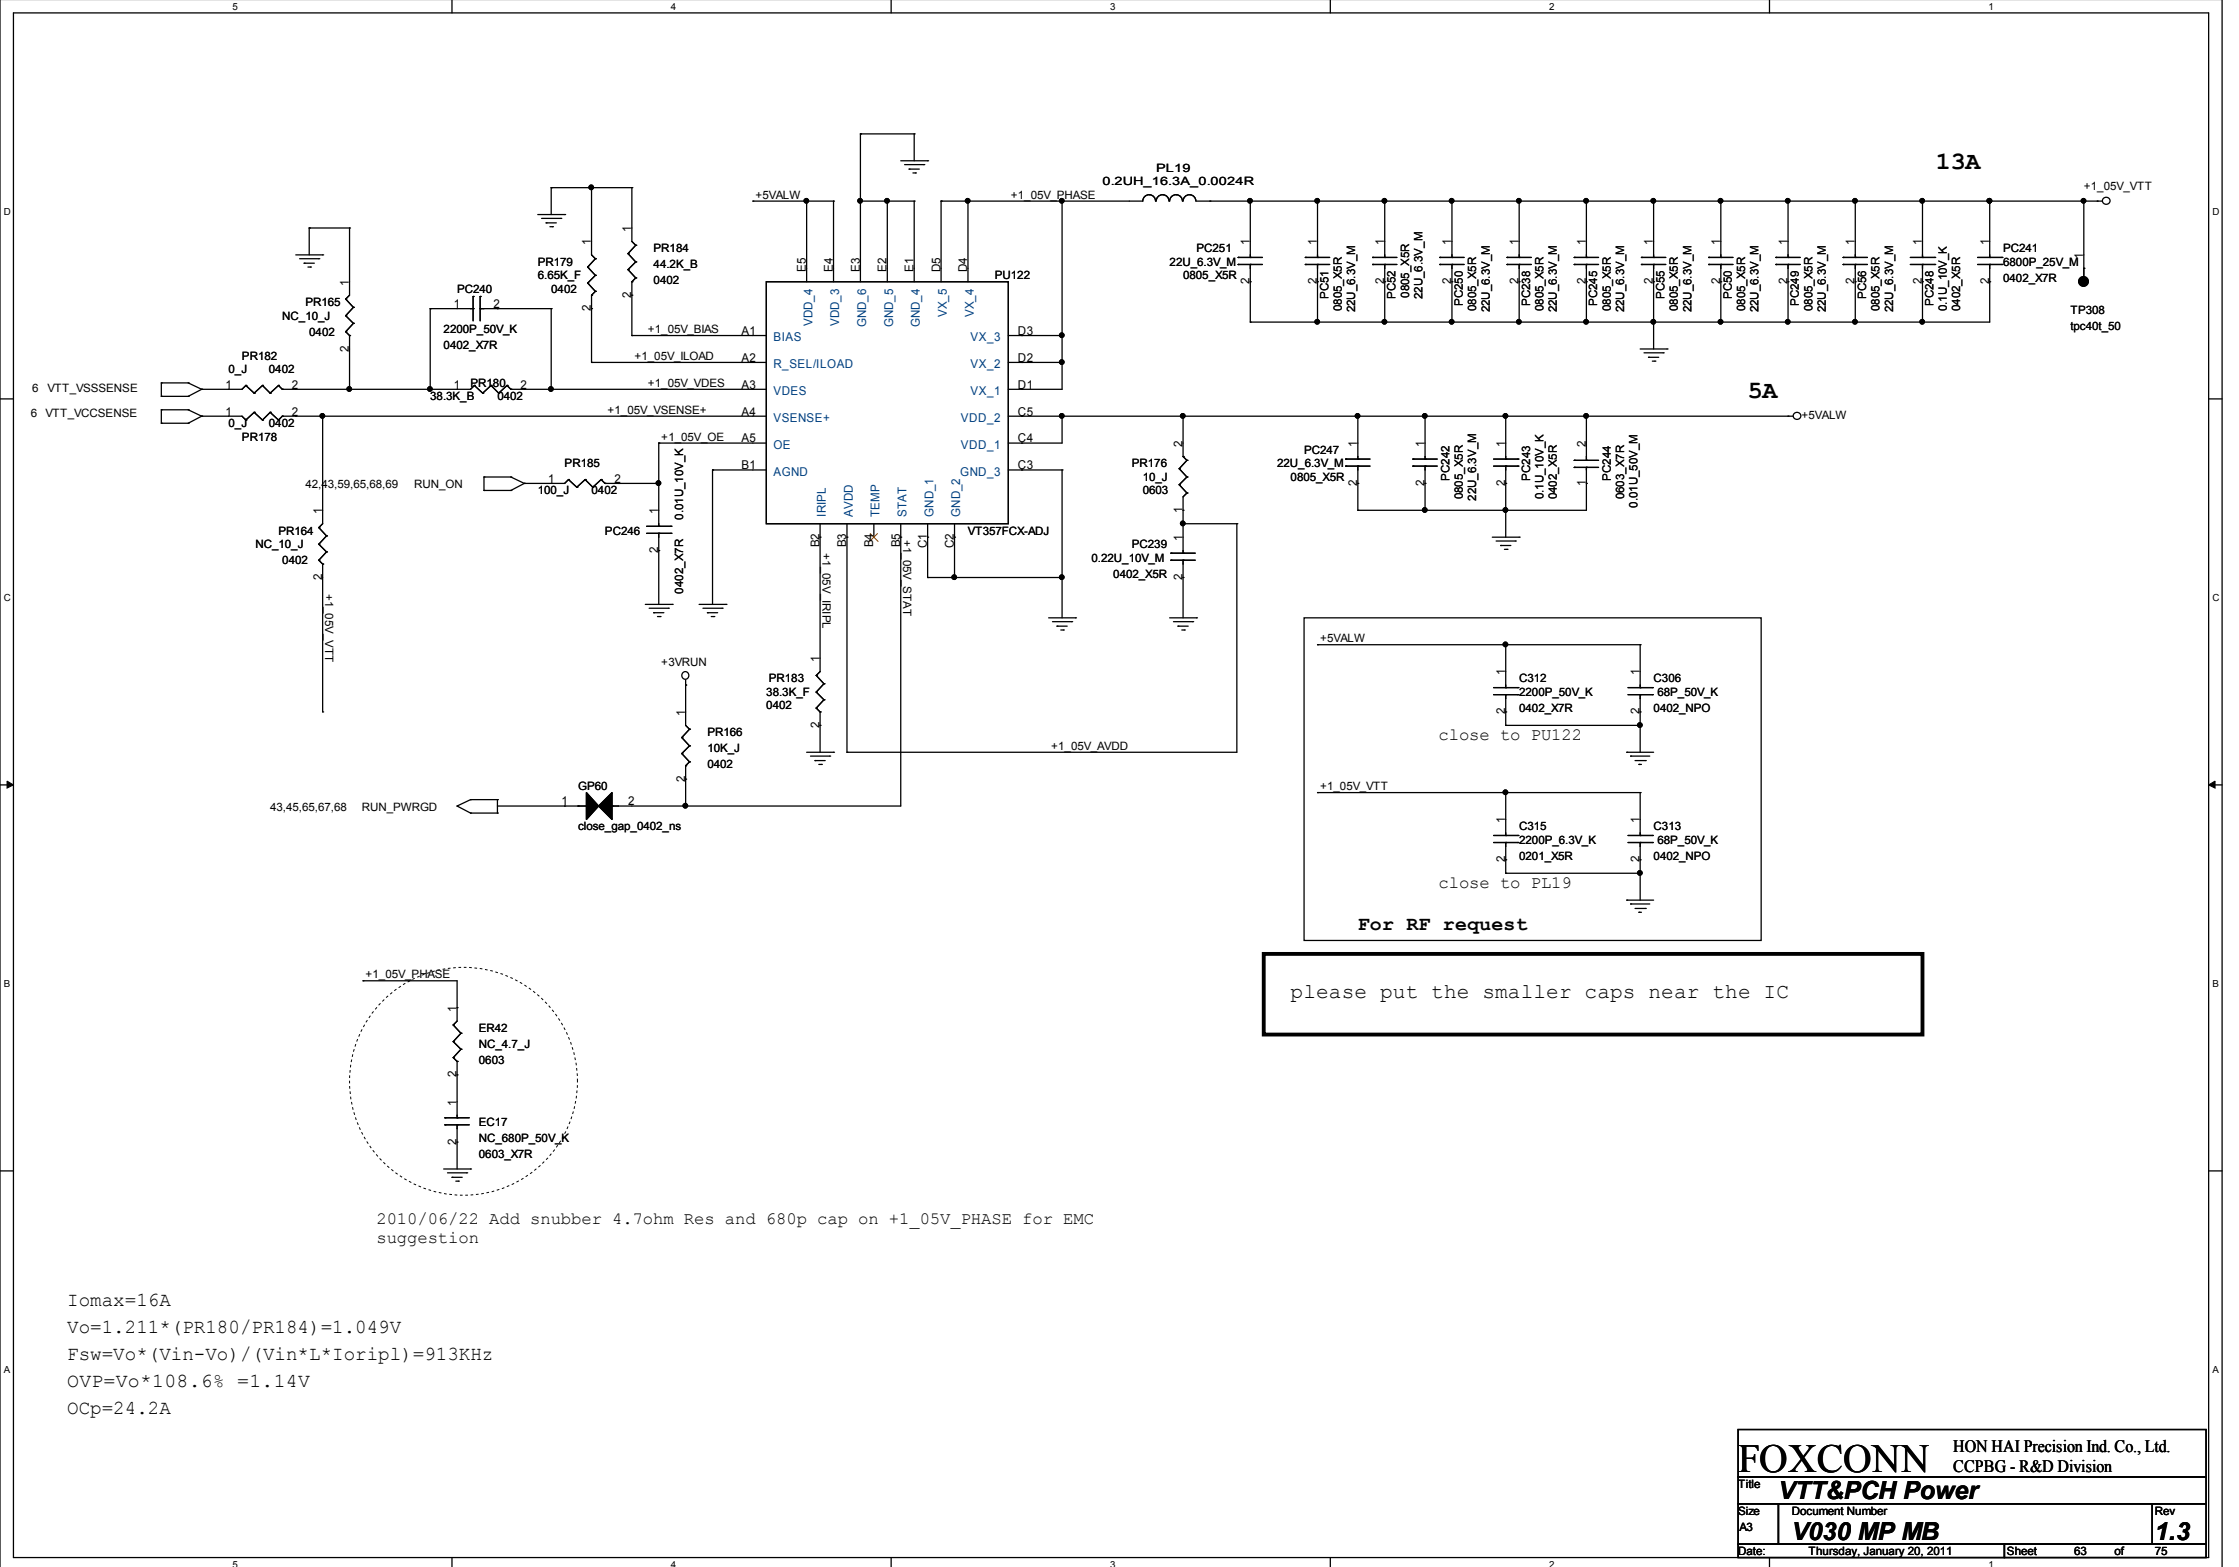
$I_{omax}=16A$   
 $V_o=1.211 \times (PR180/PR184)=1.049V$   
 $F_{sw}=V_o \times (V_{in}-V_o) / (V_{in} \times L \times I_{orip1})=913KHz$   
 $OVP=V_o \times 108.6\% =1.14V$   
 $OCp=24.2A$

$I_{\text{omax}}=12\text{A}$   
 $V_o=1.211 \times (\text{PR212}/\text{PR107})=1.504\text{V}$   
 $\text{Fsw}=V_o \times (\text{Vin}-V_o) / (\text{Vin} \times L \times I_{\text{oripl}})=833\text{KHz}$   
 $\text{OVP}=V_o \times 108.6\% =1.63\text{V}$   
 $\text{OCp}=24.2\text{A}$
